Expert statement: Risk of corrosion of mounting racks for photovoltaic plants

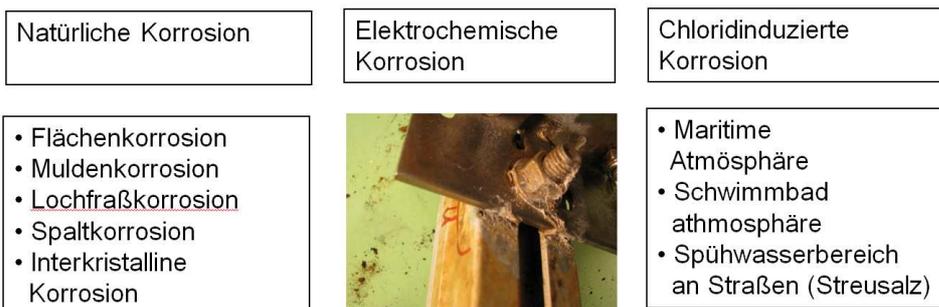
Figure 1: Types of corrosion and causes of corrosion

Even if corrosion-free materials are used that are not subject to a limitation of durability by natural corrosion, there are still two risk factors that can lead to corrosion in certain circumstances. In the first place it has to be checked in the course of designing a fastening system that consists of different metal materials, whether or not the combination of materials and the geometric proportions of the components in relation to each other grant a sufficient safety against electrochemical corrosion. When metals of different nobleness are combined, usually the less noble metal serves as a cathodic corrosion protection for the nobler metal. This effect is also known from the areas of tinsmithing and roofing, when eaves made of galvanized steel are connected with copper eaves. Already after a very short time, considerable signs of corrosion can be observed on the galvanized eaves. This effect has especially to be taken into account with clamped fastenings on roof coverings made of metal sheets. If necessary, a separation of the unequal materials by means of separating foils or coatings has to be provided.

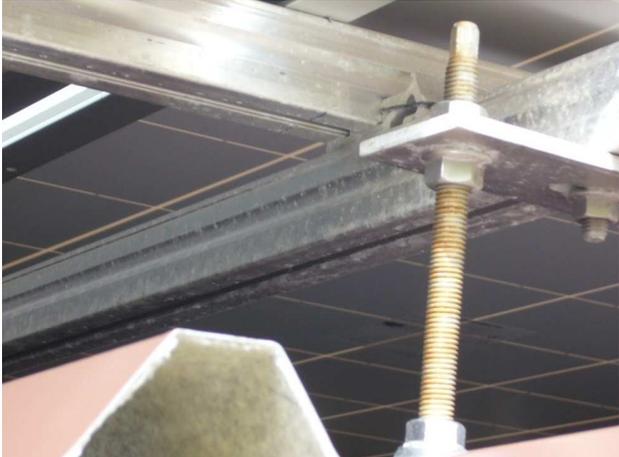
Figure 3: Corrosion signs in a coastal area

In figure 3 and figure 4, typical optical characteristics of mounting racks in proximity to the sea are displayed. On the aluminum surfaces, white precipitations may occur due to vaporized condensation water. Usually, these precipitations can only be observed in areas that are sheltered from the rain, as rain has a cleaning effect and washes away the precipitations. These white precipitations only have a visual effect and do not lead to any significant increase of the corrosion risk. In figure 3, signs of corrosion can be observed on the thread of a hanger bolt. Even if the right materials are chosen, such effects can occur if the thread was cut with ordinary steel cutting tools. This is a finite state process.

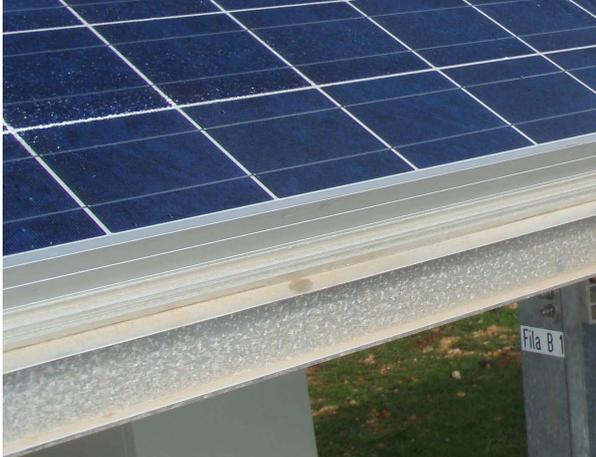
Figure 4: Precipitations on rain-protected surfaces

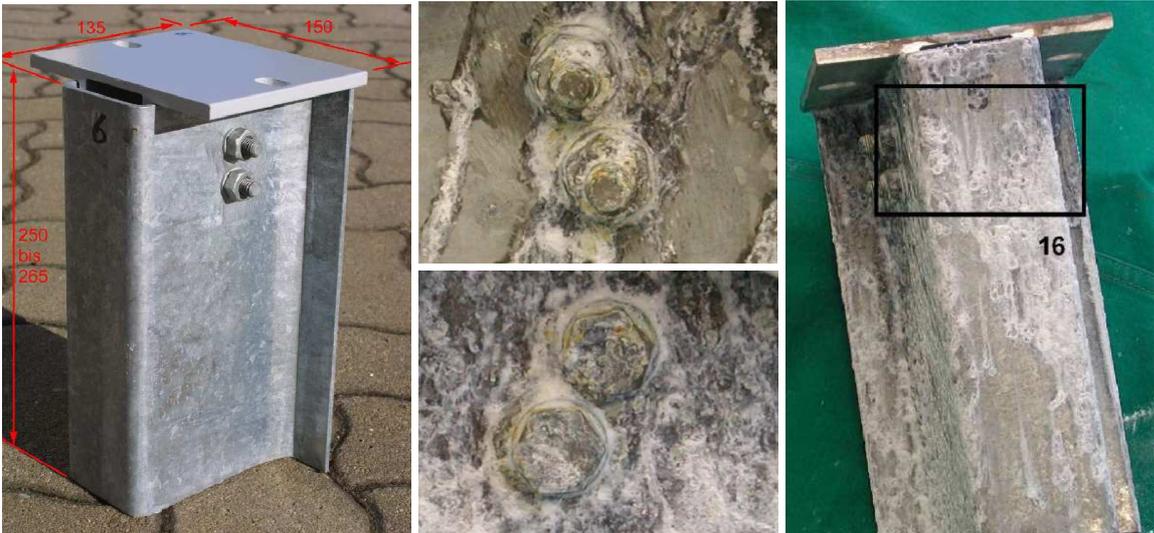
Figure 6: Material selection regarding high-grade steel in relation to the risk of corrosion

The verification of the resistance against electro-chemical corrosion of material combinations with different metals by means of calculation is only possible to a very limited extent. Usually, the verification is carried out by means of experiments. As corrosion is a lengthy process, the examination is carried out by means of salt spray tests based on DIN EN ISO 9227 in combination with DIN EN ISO 12994-6. Due to the extremely salt-containing atmosphere, the corrosion processes are considerably accelerated. Exposure times of more than 1000 hours allow for an applicability of the results for the durability of solar plants in normal atmospheric conditions. At the same time, the risk can also be tested in "close to the sea" conditions. Figure 6 shows a test body with a material combination made of galvanized steel, aluminum and high-grade steel screws before and after the test series. In the present case, no corrosion damage could be observed.

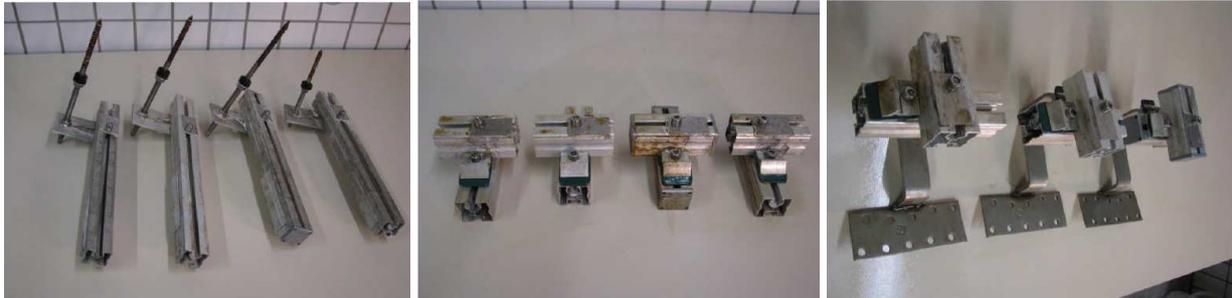
Figure 7: Test bodies with different fastening details after a successful salt spray test

Salt spray tests have been carried out by expert institutes like the welding training and testing institute SLV or the specific departments of the Landesgewerbeamt LGA (federal craft institute). At the same time, the report contains an expert evaluation of the corrosion risk. Figure 7 shows a series of test bodies after completion of the salt spray tests with positive results. On the surfaces of the test bodies, salt precipitations and spray traces can be observed. In these examples, no significant corrosive action was observed that would give reason to suspect any danger to the structural safety of the photovoltaic plant during the intended service life.
